OFFICIAL NOTICE NO. 155

**ADDENDUM NO. 1**

**PRE-DEMOLITION BUILDING ASSESSMENT FOR ASBESTOS,  
LEAD-BASED PAINT AND HAZARDOUS MATERIALS**

**Project Area B  
Building 64W40**

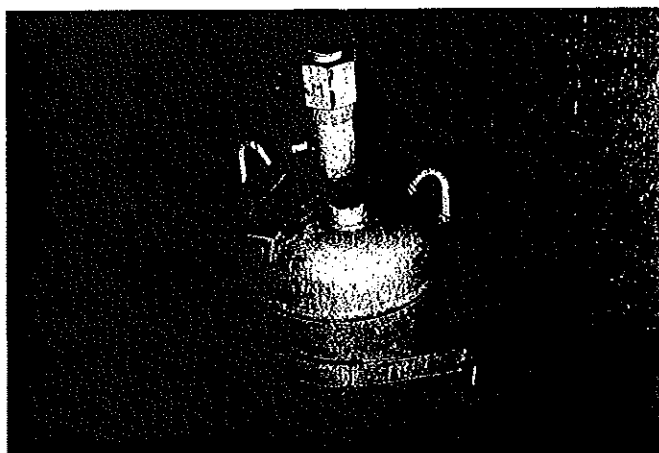
6. Photo of the tank of halon for the fire suppression system on the 2nd level of Building 64W40.

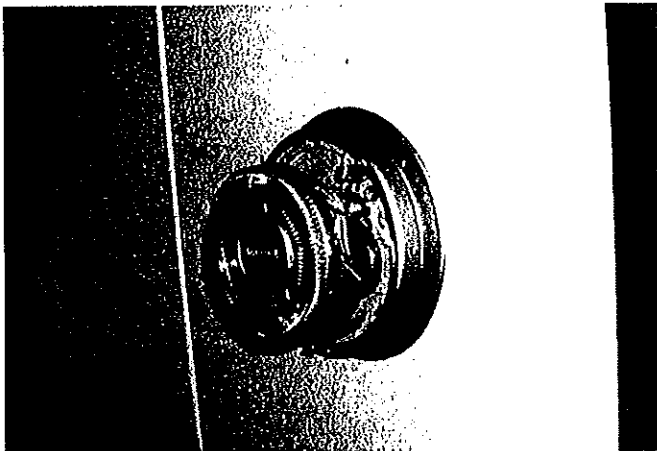
9. Photo of a mercury switch observed in the 1st level conference room.

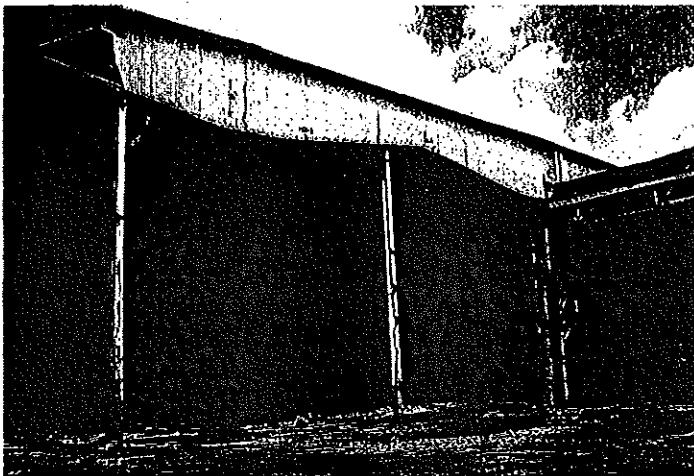
The remaining roof deck of Building 58 was covered with a black, fibrous, multi-layer sheet roofing material and black, resinous flashing material. The observed roofing materials appeared to be homogenous with the materials over the south adjoining roof section of

Building 52. As such, considering that a laboratory analysis result of the roof material sample from Building 52 is ACM, the observed homogenous roofing material over Building 58 is assumed ACM. Additionally, a gray, resinous caulk or grout compound was observed over the seams/joints of the east side parapets of Building 58. The observed parapet seam/joint compound appeared homogenous with the parapet seam/joint material at the adjoining Building 51. As such, considering that a laboratory analysis result of the parapet seam/joint compound sample from Building 51 is ACM, the observed homogenous parapet seam/joint compound material at Building 58 is assumed ACM.

2. View of Building 58 Main roof .
